Annual Inspection Report
Word Field Municipal Airport

# ANNUAL INSPECTION REPORT MARCH 7, 2011

SCOTTSBORO MUNICIPAL AIRPORT WORD FIELD SCOTTSBORO, ALABAMA

March 7, 2011

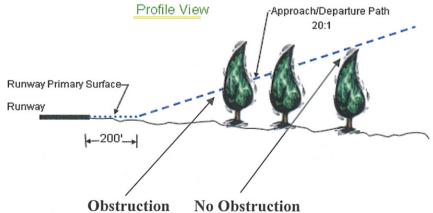
Approach and Departure Path Dimensions				
Inner	Outer			
Width	Width	Length	Acreage	
250 Feet	450 Feet	1,000 Feet	8.04 Acres	
Primary Surface Dimensions				
250 Feet Wide Centered Along Runway Centerline				
Extending 200 Feet Past the Runway End				
Runway Safety Area Dimensions				
120 Feet Wide Centered Along Runway Centerline				
Extending 200 Feet Past the Runway End
